# Test Report

No. NGBHG1903555601

JIN HUA DA RONG PAINT CO.,LTD

Test Requested	Conclusion
FDA 21 CFR 175.300–Total extractives	PASS

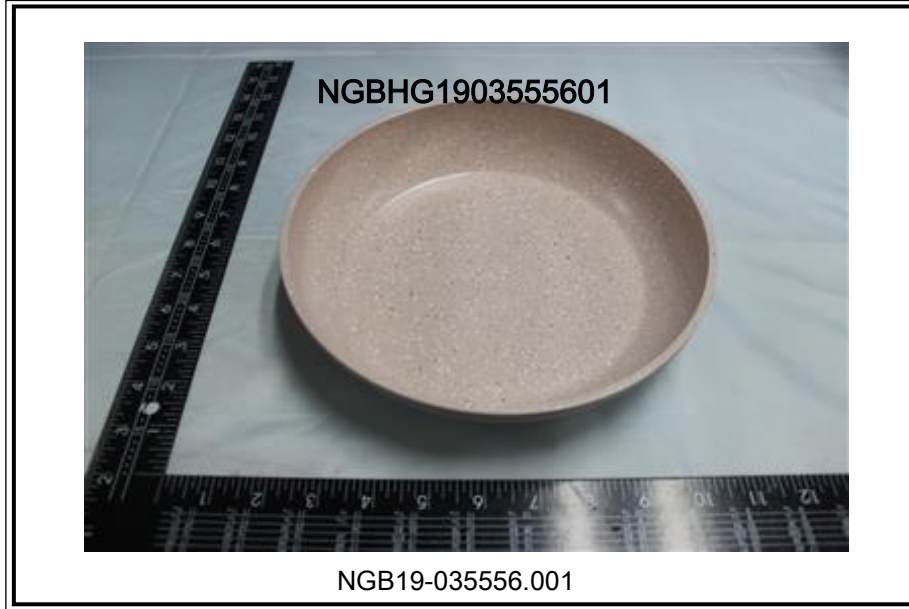
Sample photo:

Specimen No.	SGS Sample ID	Description	Material (claimed by the client)
SN1	NGB19-035556.001	Silvery metal pan with pink & white ,black ceramic coating	METAL + CERAMIC COATING
